# TEKAPO POWER SCHEME

# 13

This report summarises the key outcomes at the Tekapo Power Scheme for the operating period 1 July 2012 to 30 June 2013. There are a number of technical reports, research programmes, environmental initiatives and agreements that have fed into this report; it is not the intention of this report to reproduce or replicate this information, rather to provide a summary of it. Genesis Energy is happy to provide further details or technical reports or discuss matters directly with interested parties.

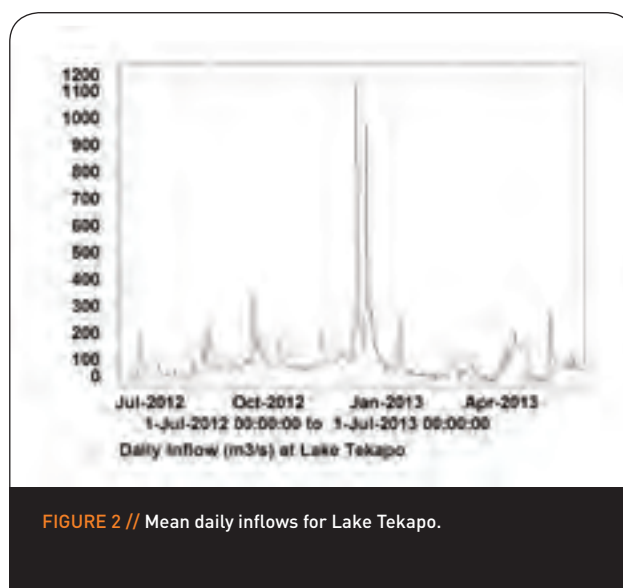
The period of extreme inflows was immediately followed by an extended period of significantly below average rainfall which extended from February to until the start of June. Rainfall totals during this period were consistently low at approximately 50% of the long-term average.

FIGURE 2 // Mean daily inflows for Lake Tekapo.

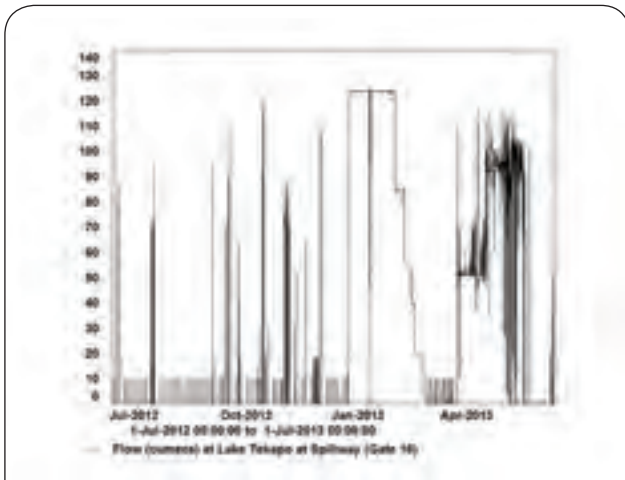
Figure 4 presents flow data for the Tekapo River between the Lake Tekapo Control Structure and Lake George Scott weir. Flow from Lake Tekapo Control Structure was 100% compliant with the maximum consented flow during the reporting period as shown in Table 3.

FIGURE 4 // Flow via the Lake Tekapo Control Structure during the reporting period.

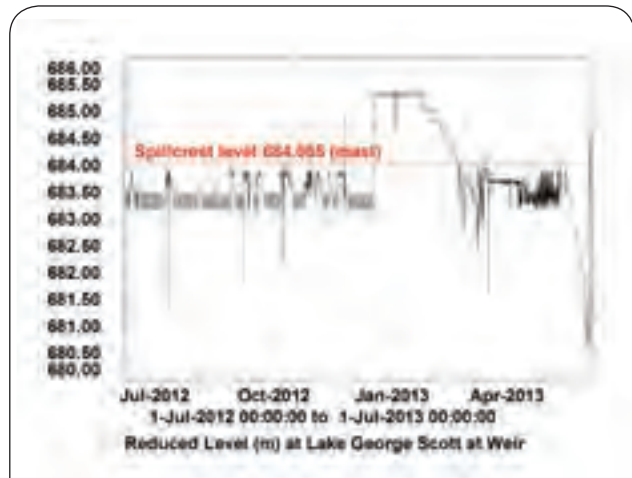
Genesis Energy operates Lake George Scott to a level of 684.05 masl which is also the level of the spillcrest of the weir. Figure 5 shows the level of Lake George Scott during the reporting period. Once the maximum level of Lake George Scott is reached, spill occurs down the Tekapo River. Spill from Lake George Scott weir is enabled under resource consent CRC905309.4 and maximum level of Lake George Scott is determined by compliance with the spill rules. During the reporting period Lake George Scott maximum level and flow over Lake George Scott weir was 99.79% compliant (Table 4). This compliance result is explained in the following section (CRC905309.4).

FIGURE 5 // Lake George Scott lake level during the reporting period.

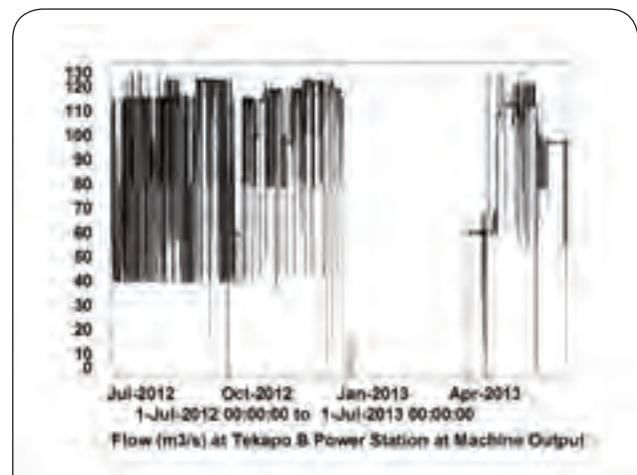
Flow into Lake Pukaki via Tekapo B Power Station was below the maximum consented flow for the duration of the reporting period (Figure 9) and was 100% compliant (Table 8).

FIGURE 9 // Flow into Lake Pukaki via Tekapo B Power Station during the reporting period.

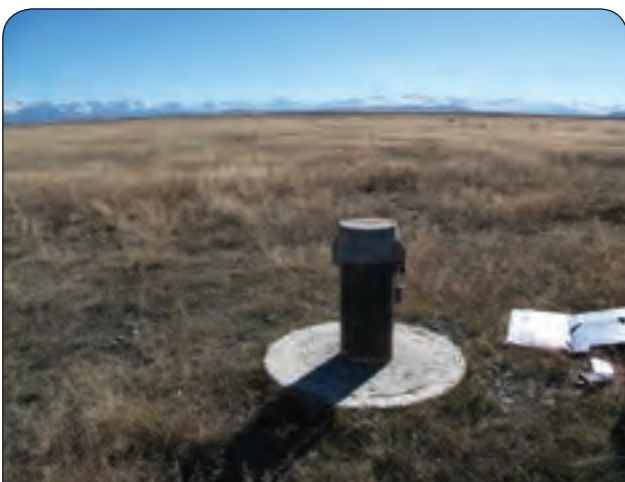
**FIGURE 12 //** A bore on Gray's Hills Station (adjacent to the Tekapo River) which was assessed for its potential to have a pressure transducer installed.

A field visit to the Tekapo River was undertaken on 8 May 2013 to determine the suitability of a number of bores for the installation of pressure transducers, to measure groundwater levels (Figure 12).

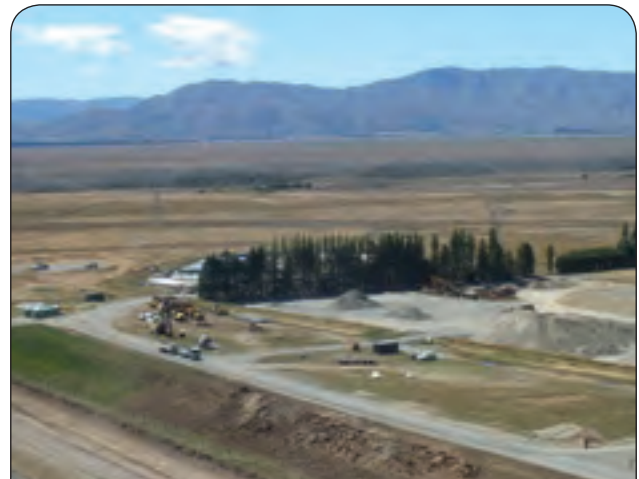
FIGURE 14 // Construction Management Site for the Tekapo Canal Remediation Project.

In September 2012, Genesis Energy commenced the re-lining and repair works project by first establishing a Construction Management Site on a parcel of land owned by Genesis Energy, situated approximately 8 km down the Tekapo Canal from Tekapo A Power Station. The Construction Management Site consisted of workshops and site offices from where the canal project was managed. The Construction Management Site is also where a large proportion of the aggregate used for the project was excavated from borrow pits (Figure 14).

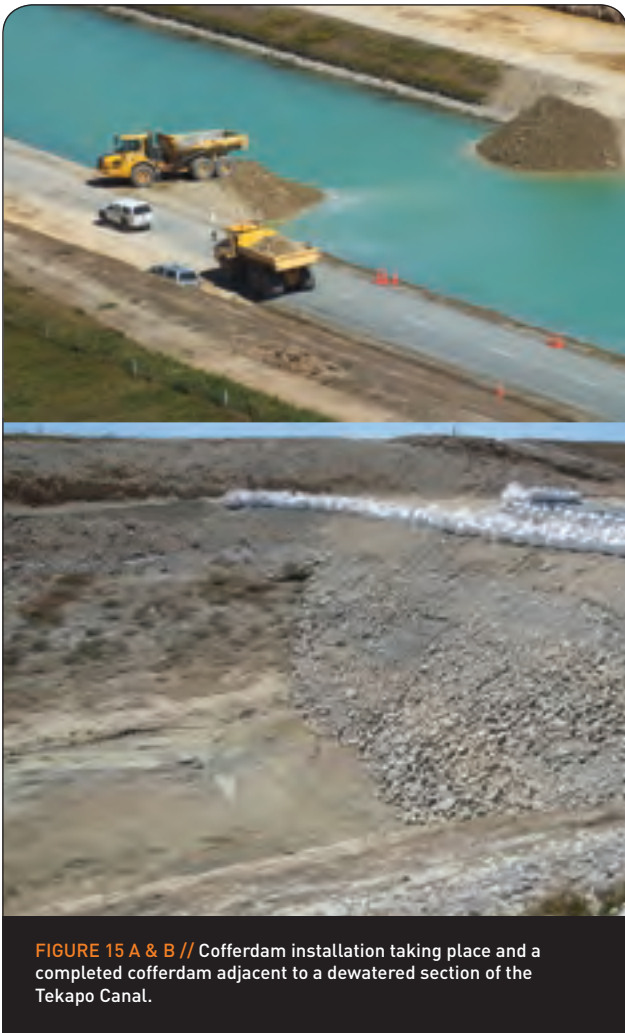
On 9 January 2013, Genesis Energy stopped the flow of water in the Tekapo Canal, so that the coffer dams could be installed to allow for the dewatering of the two canal sections to be repaired during the summer of 2013 (Figure 15 a – b).

**FIGURE 15 A & B //** Cofferdam installation taking place and a completed cofferdam adjacent to a dewatered section of the Tekapo Canal.

Once the coffer dams were installed, and had been tested for stability by engineers, de-watering of the isolated canal sections to be repaired, began. Large pumps were deployed into the canal, and over the course of six days, the water was removed from the two sections of the canal.

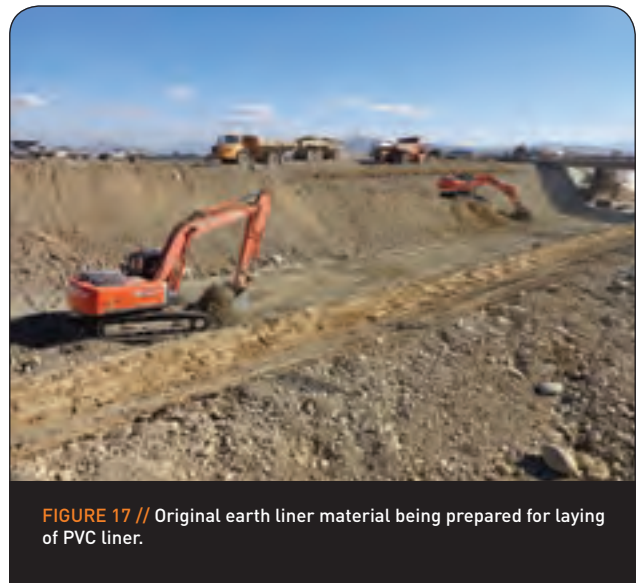
As soon as the water had been removed from the two sections of the canal, machinery entered onto the dry canal bed to commence removing weed and loose material sitting on top of the original earth liner of the canal (Figure 17). Once the existing liner surface had been repaired, sand was laid within the canal as a base course, prior to the specialised PVC liner material being laid.

**FIGURE 17 //** Original earth liner material being prepared for laying of PVC liner.

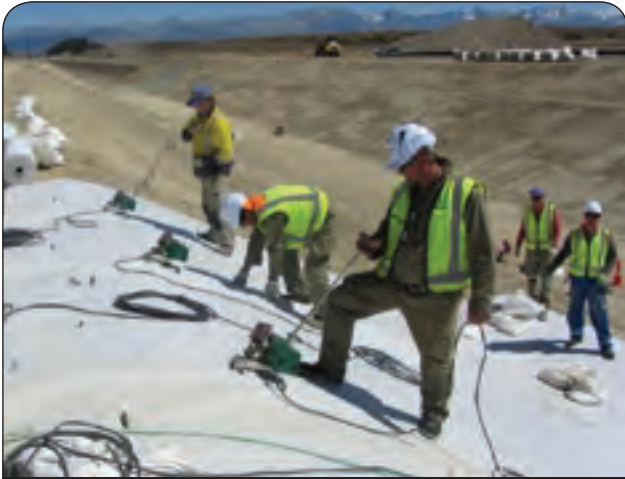
The specialised PVC liner material is produced in Italy and Spain, by the company Carpi Tech. The rolls of liner were deployed from the bank of the canal, and rolled down to the bottom of the canal. The liner edges were then welded together with specialised welding equipment which heated the liner material to 200°C to form a continuous welded seam (Figure 18). Each seam was then pressure tested to ensure a continuous leak-free liner.

FIGURE 18 // Welding equipment joining sections of liner together.

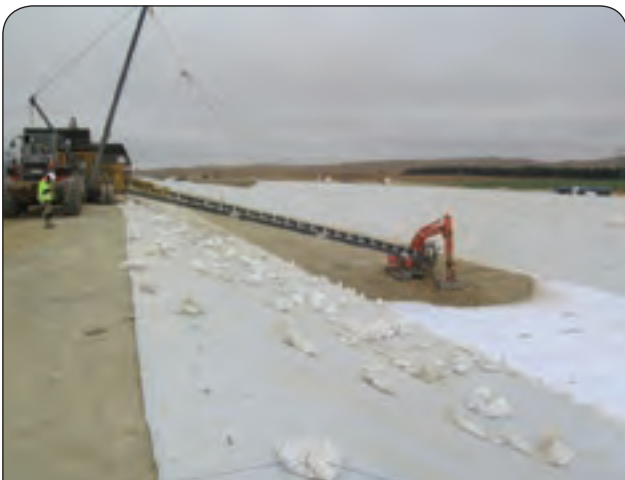
Once sections of liner were welded together, rock ballast material was conveyed to the bottom of the canal. The ballast material was placed at the bottom of the canal to anchor the liner material in place once the canal was re-filled with water. The ballast material was transported to the base of the canal by a custom-made conveyor belt system called the 'juggernaut' (Figure 19).

FIGURE 19 // The 'juggernaut' in action, conveying rock ballast material to the bottom of the canal.

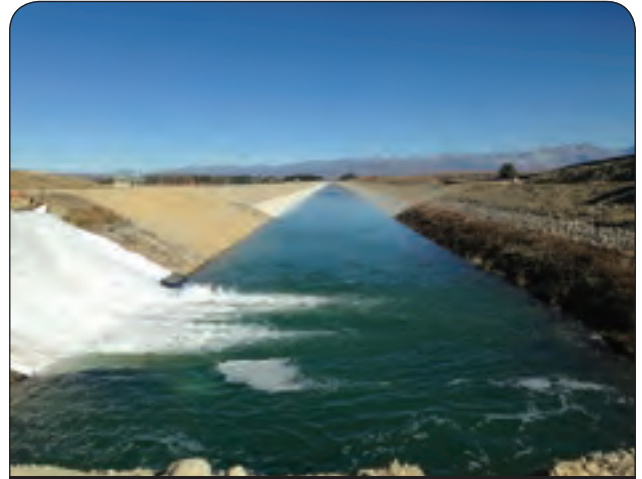
When both sections of the canal had undergone re-lining and the ballast was laid, water was pumped back into the empty sections of the canal (Figure 20). Following the removal of the four cofferdams, the canal was brought back into service on 12 April 2013, marking the end of a successful first season for the Tekapo Canal Remediation Project.

FIGURE 20 // Re-watering a repaired section of the Tekapo Canal.

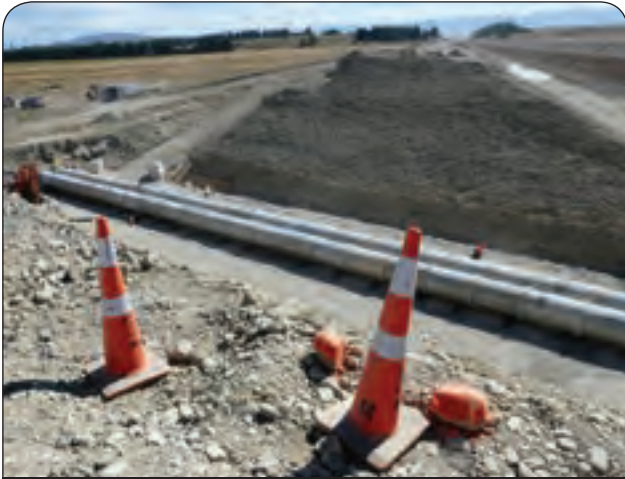
Permanent remediation works to the 8.17 km culvert took place in early 2013, in conjunction with the season one canal re-lining works (Figure 22). The remediation works involved replacing the damaged embankment and existing earth liner at the location of the double culvert, removal and replacement of the culvert, and removal of the buttress structures that were no longer required.

**FIGURE 22 //** 8.17 km culvert pipes being installed.

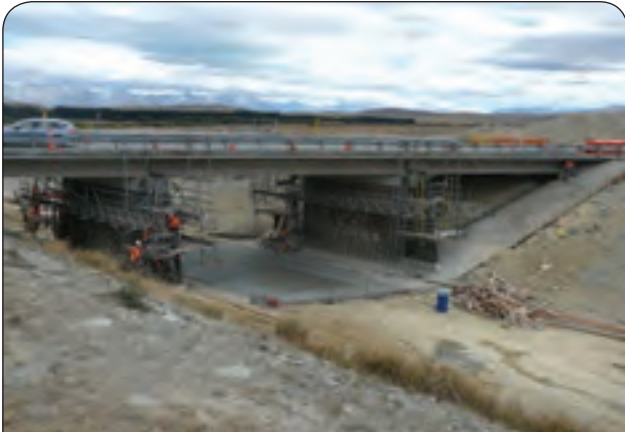
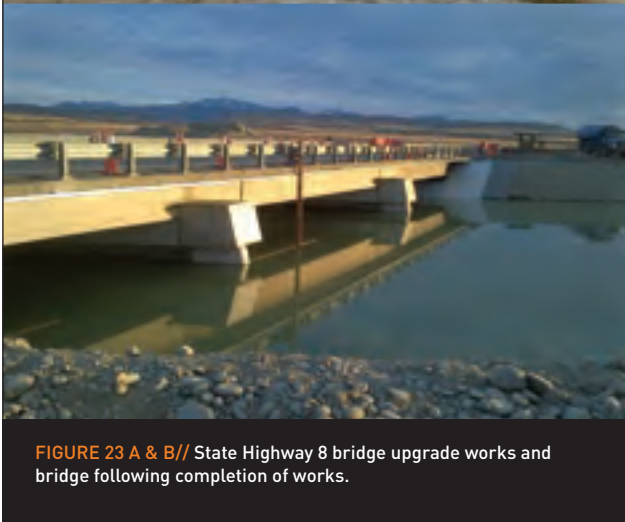
Seismic strengthening of the State Highway 8 (SH 8) bridge, which crosses over the Tekapo Canal, was also undertaken during the canal re-lining season. Works to the SH 8 bridge and surrounding canal included excavating around the bridge foundations and pouring additional concrete foundations linked to the existing bridge columns to provide a strengthened and more stable bridge structure capable of withstanding a significant seismic event (Figure 23 a - b). This strengthening will also stop any scouring of the sides of the canal bank.

**FIGURE 23 A & B//** State Highway 8 bridge upgrade works and bridge following completion of works.

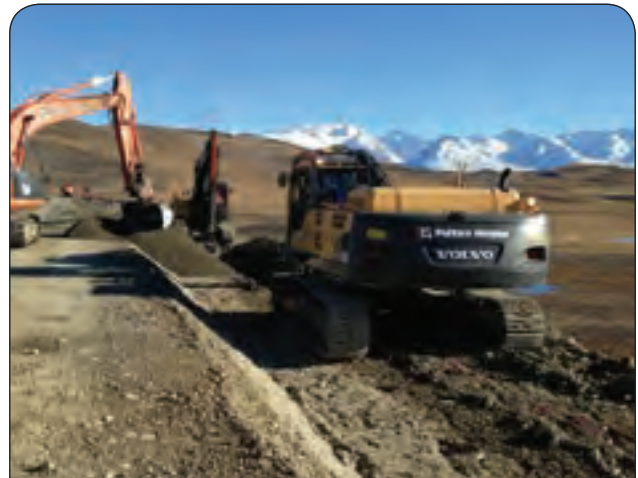
The Maryburn Fill embankment contains a 'filter' layer beneath the canal. This filter layer is a critical design element of an earth fill embankment as it provides a channel to control any seepage, allowing it to be drained away without weakening the structure of the embankment. At the Maryburn fill, the existing filter installed at the time of construction, did not extend high enough within the embankment to meet modern engineering requirements. As such, a trench was excavated down from the crest (top) of the canal into the existing filter. New filter material was put into the trench and the surrounding aggregate re-instated. The filter layer was extended at the Maryburn Fill by approximately two metres up the sides of the embankment to the crest level. Both sides of the Maryburn fill received this treatment, and works were completed at the end of June 2013. The work was undertaken while the Tekapo Canal was in service (Figure 24), with appropriate water level and canal volume limits in place.

**FIGURE 24 //** The Maryburn Fill embankment and external earthworks.

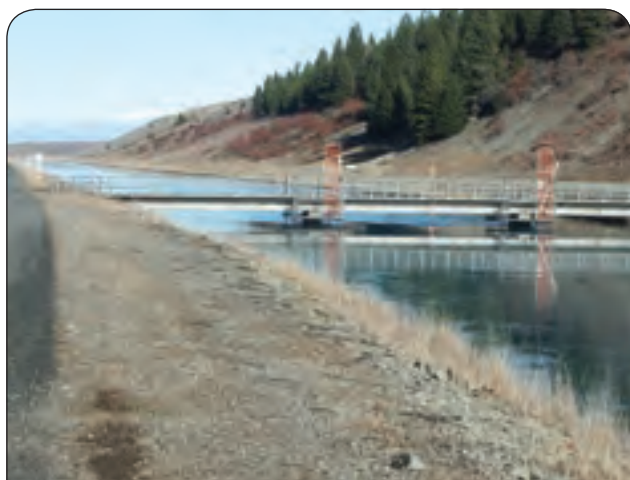
The three farm bridges which cross over the Tekapo Canal (Figure 25) were also upgraded during June and July 2013, while the Tekapo Canal was in service. Temporary scaffolding was bolted onto the outside of the bridges to facilitate the works. Reinforcement bracing was added to key support beams under the bridge decking to strengthen the bridges against seismic events.

**FIGURE 25 //** No. 1 Farm Bridge undergoing seismic strengthening works.

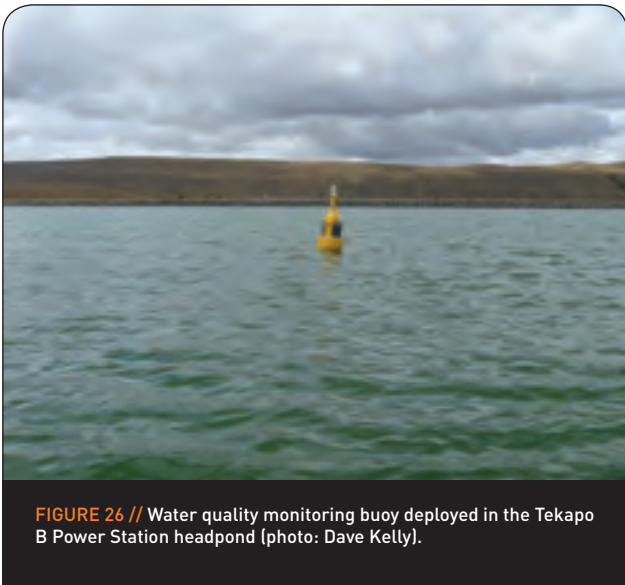
A water quality monitoring buoy was installed in the head pond above Tekapo B Power Station shortly after the canal outage commenced (Figure 26). The monitoring buoy measured Dissolved Oxygen (DO) at a depth of 15 m, and temperature at depths of 1 m and 15 m in the head pond. The head pond had previously been identified as the appropriate site for monitoring as any water quality issues associated with the canal outage would first develop in the head pond due to its depth, and accumulation of detritus on the base of the head pond (Kelly, 2012).

**FIGURE 26** // Water quality monitoring buoy deployed in the Tekapo B Power Station headpond (photo: Dave Kelly).

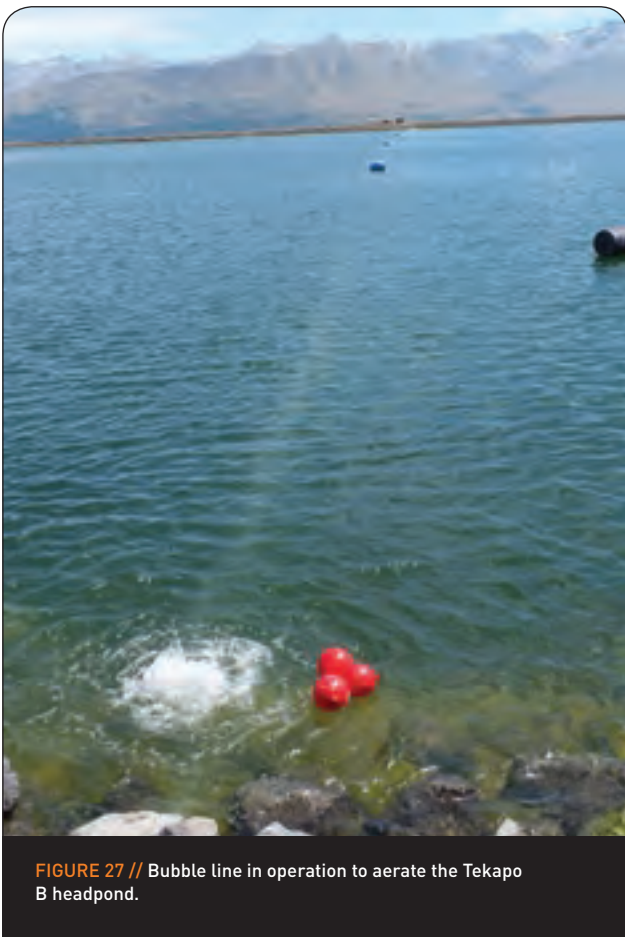
In response to dissolved oxygen levels dropping below the 50% dissolved oxygen threshold stipulated in Genesis Energy’s Water Quality SMP, intervention and further monitoring measures were enacted. The intervention involved placing a compressor-run bubble line across the length and near to the bottom of the head pond, which oxygenated and encouraged water circulation within the head pond (Figure 27). As a result, dissolved oxygen levels effectively increased and were predominantly maintained at levels above 70% throughout the remainder of the outage (Kelly & Barter, 2013) (Figure 28).

**FIGURE 27** // Bubble line in operation to aerate the Tekapo B headpond.

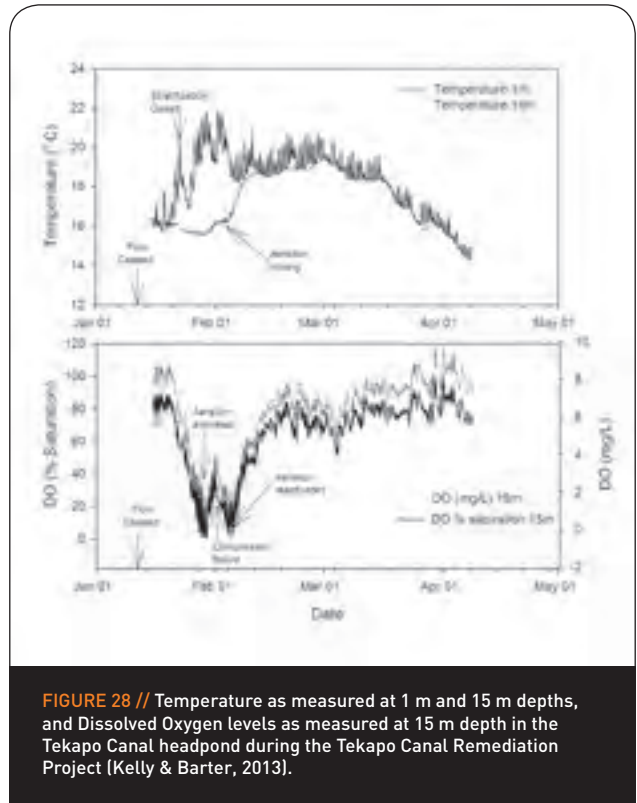
**FIGURE 28** // Temperature as measured at 1 m and 15 m depths, and Dissolved Oxygen levels as measured at 15 m depth in the Tekapo Canal headpond during the Tekapo Canal Remediation Project (Kelly & Barter, 2013).

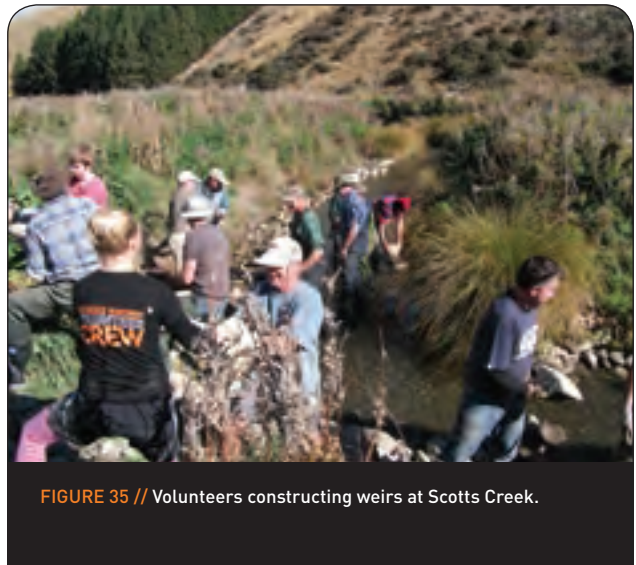
FIGURE 35 // Volunteers constructing weirs at Scotts Creek.

Scotts Creek has a flow of around 80 litres per second and to maximise the distribution of spawning, the right depth and velocity characteristics for trout spawning need to be maintained. In combination with the grooming works at Scotts Creek, in the last four years artificial weirs have been created to improve flow characteristics to enhance conditions for trout spawning. This has been achieved using hand constructed rock weirs.

After the digger grooming work occurred in late March 2013 at Scotts Creek, the Lake Alexandrina Conservation Trust held a work day when weirs were reinstated and others added as required. More than 30 volunteers attended this day including staff from Genesis Energy (Figure 35). Approximately 90 weirs were constructed and the stream bank was also narrowed and protected by boulder placement in several reaches totalling approximately 100 m on each bank (Figure 36).

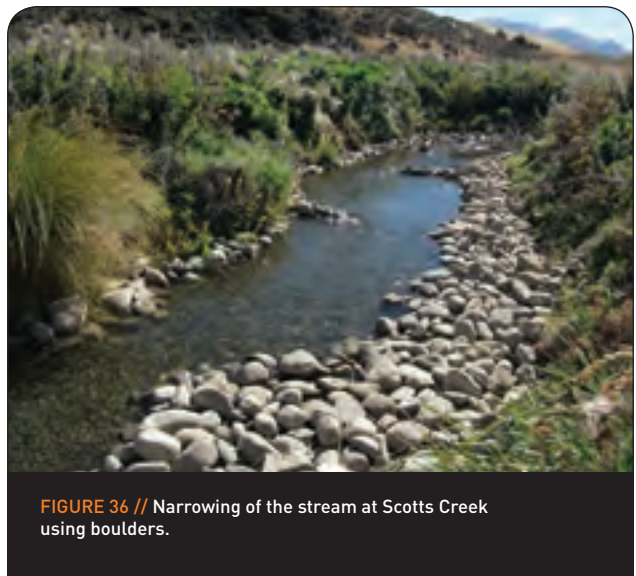
FIGURE 36 // Narrowing of the stream at Scotts Creek using boulders.

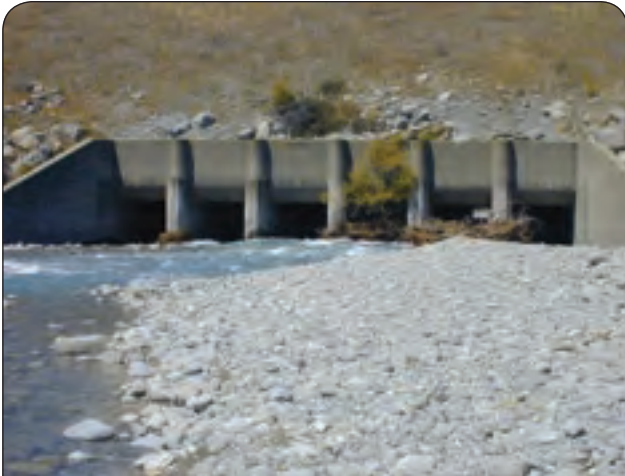
FIGURE 37 // Build up of debris upstream of Fork Stream culvert.

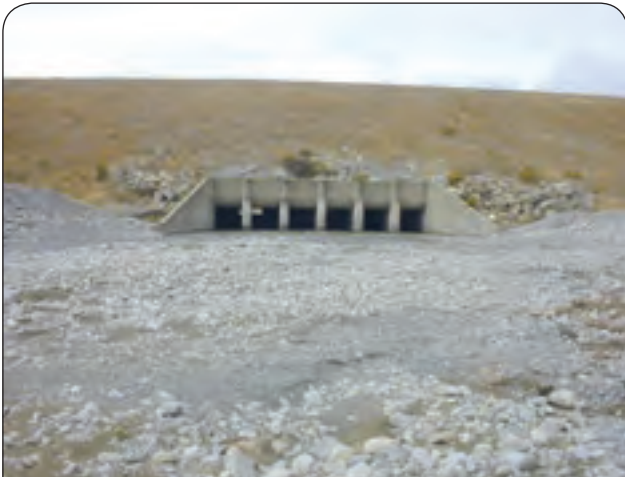
FIGURE 38 // Fork Stream culvert clear of debris following maintenance works.

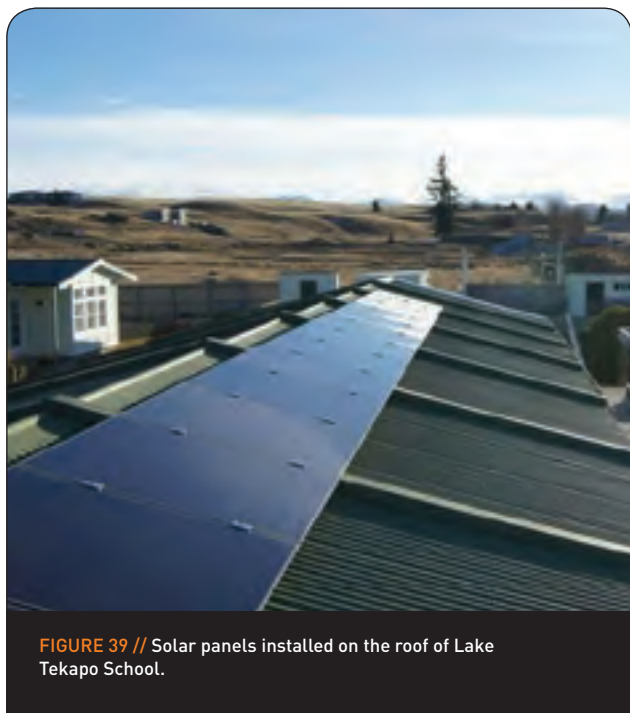
FIGURE 39 // Solar panels installed on the roof of Lake Tekapo School.

**Schoolgen** Schoolgen is a Genesis Energy initiative bringing solar energy and energy efficiency to life for New Zealand schools. Lake Tekapo School became a Schoolgen school in July 2013 and is the only school in New Zealand to have the ability to store the electricity they have generated from their own solar panels, in a battery bank (section 9.1).

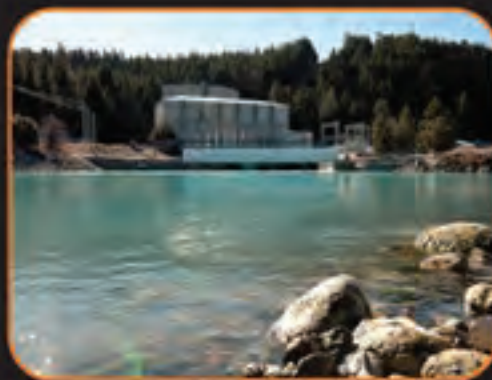
**TEKAPO A POWER STATION**  
One 25 MW Unit. Commissioned 1951

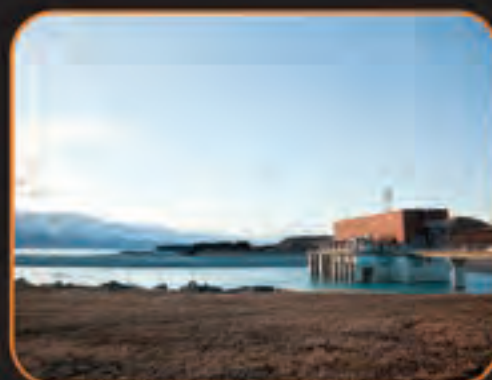
**TEKAPO B POWER STATION**  
Two 80 MW Units. Commissioned 1977
